Report to the University of Hawaii at Manoa on the Hydrogen/Oxygen Explosion of March 16, 2016

Report 1: Technical Analysis of Accident

Prepared by the UC Center for Laboratory Safety, June 29, 2016

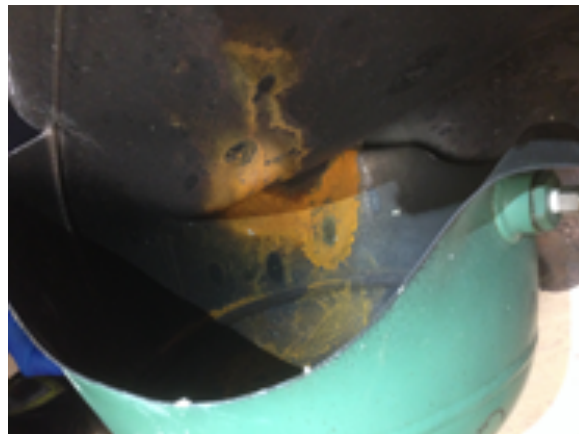
Figure 5: Rust inside the damaged gas storage tank as observed by the Investigative Team.

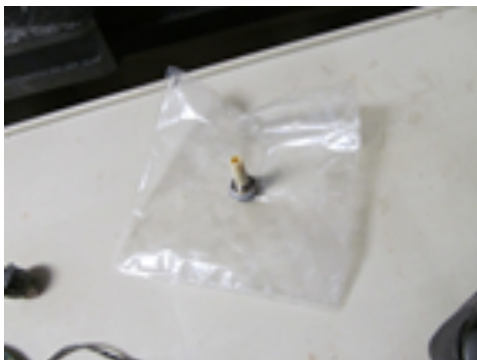
Figure 6: Gas sampling bag found in the UH laboratory with polyethylene tubing attached.

- Sampling of the tank mixture at pressures of 90 psig and higher using a ball valve and a thin fluorinated ethylene propylene (FEP) 500 mL sampling bag is not a safe practice. The bag pressure could easily have exceeded the burst pressure of <20 psig. A needle valve would be a safer valve to control the flow of a gas sample. In addition, the sample bag was friction fitted over a plastic tube stub rather than attached by a threaded connection and could have easily been dislodged during filling.
- However, any type of valve could cause flow friction and be a point of ignition for an explosive gas mixture and the sampling bag could generate an electro static discharge that could have also ignited the explosive gas mixture. Thus, standard practices with nonreactive gases are not directly transferable to explosive gases.

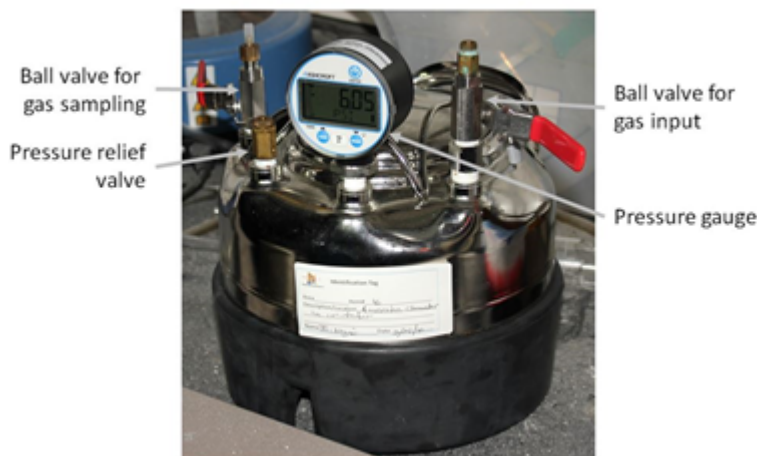
Figure 7: Pressure vessel (1 gallon). The pressure vessel as shown here was equipped with an Ashcroft pressure gauge, a pressure relief valve and two ball valves. When found, the pressure gauge showed an unusually high pressure of 60.5 psig.

The day before the devastating accident, the postdoctoral researcher reported a “cracking” sound inside the vessel after she had pushed the On/Off button on the Ashcroft pressure gauge³⁵. She had already pressurized the vessel with the specified gas mixture and was about to place it into the incubator oven. Following the noise, the postdoctoral researcher noticed an immediate drop in pressure as hydrogen and oxygen had probably reacted to form water vapor that condensed³⁶. She opened the vessel and noticed a burning smell. The petri dishes were cracked and discolored³⁷. The gas mixture in the incubator may not have been well mixed. As a result a deflagrating reaction occurred that did not transition to a detonation that would have ruptured the incubator.

The postdoctoral researcher was clearly alarmed as she reported the incident to her PI and also to another postdoctoral researcher in the lab³⁸. The PI advised her not to use the vessel again³⁹, however, the Investigative Team found the pressure vessel inside the 30°C incubator oven during their investigation of the UH laboratory. The vessel was pressurized to 60.5 psig and contained bacterial cultures. It was equipped with an Ashcroft pressure gauge, which was sent out for forensic examination. Based on the gauge’s manufacturing date (January 2016), the gauge was the same as the one used during the near miss event.

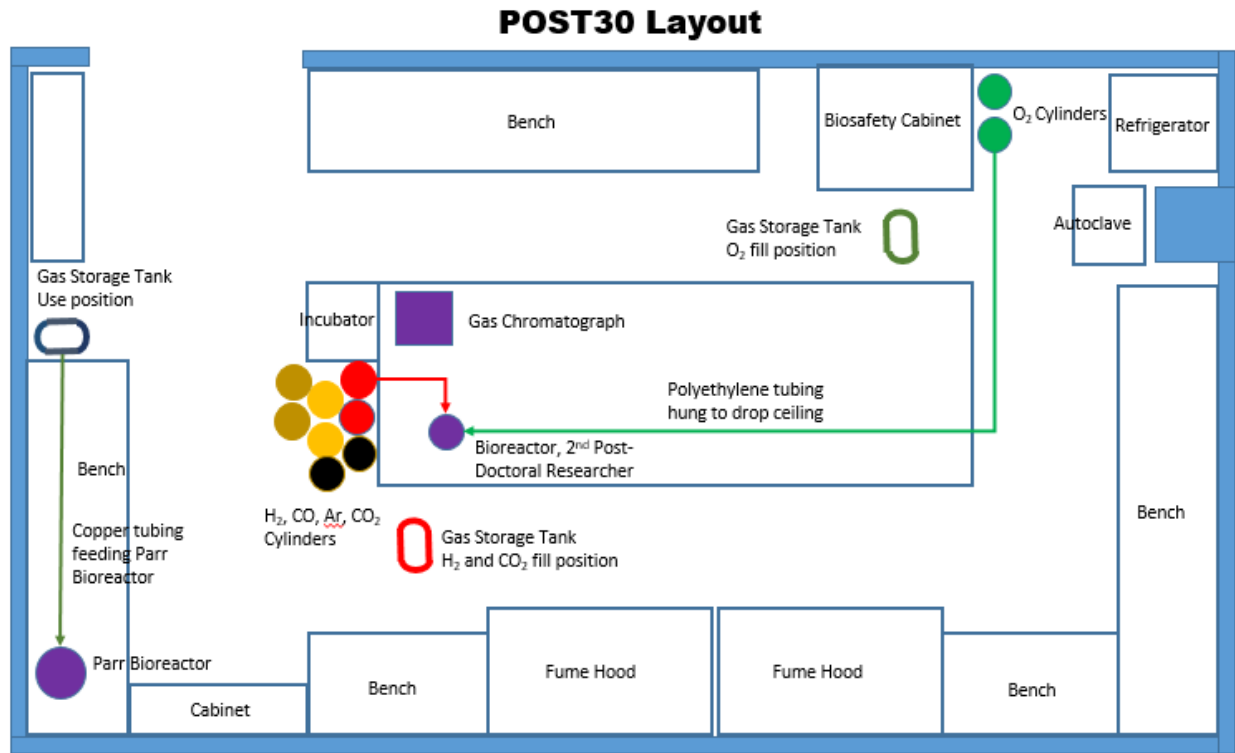
Figure 8: POST 30 laboratory layout. Entry double doors are at the top left. Oxygen cylinders (green) were stored separately from other gas cylinders. The gas storage tank's position is indicated in the position when it was used to feed the gas mixture to the Parr bioreactor (Use position). In front of the biosafety cabinet (O₂ fill position), where it was filled with oxygen and by the other cylinders where it is filled with hydrogen and carbon dioxide (red tank). Green and red (hydrogen) lines indicate gas lines to the second postdoctoral researcher's experiment, which was ongoing during the time of the accident. The carbon dioxide line is not shown.

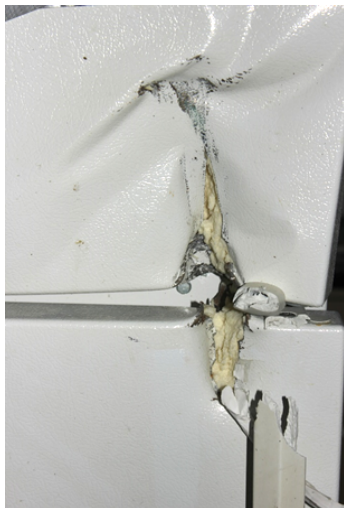
Figure 10: Damage to a -20°C refrigerator and freezer doors in the POST 30 laboratory. The doors show severe impact damage by the gas storage tank piece shown below. The paint residue on the doors match the tank's paint.

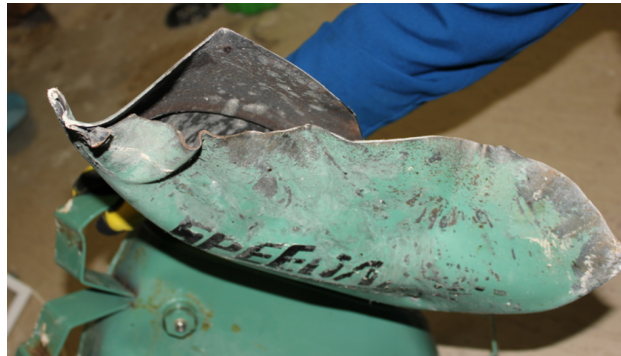
Figure 11: The impact distorted edge of the tank that most likely punctured the refrigerator and freezer doors

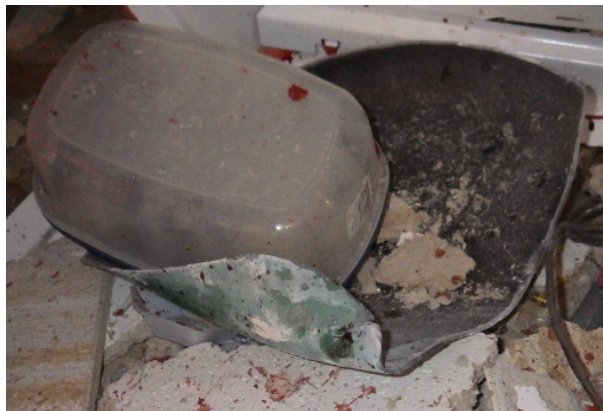
Figure 13: Piece of tank that impacted the autoclave on the floor to left of the biosafety cabinet as found by HFD.

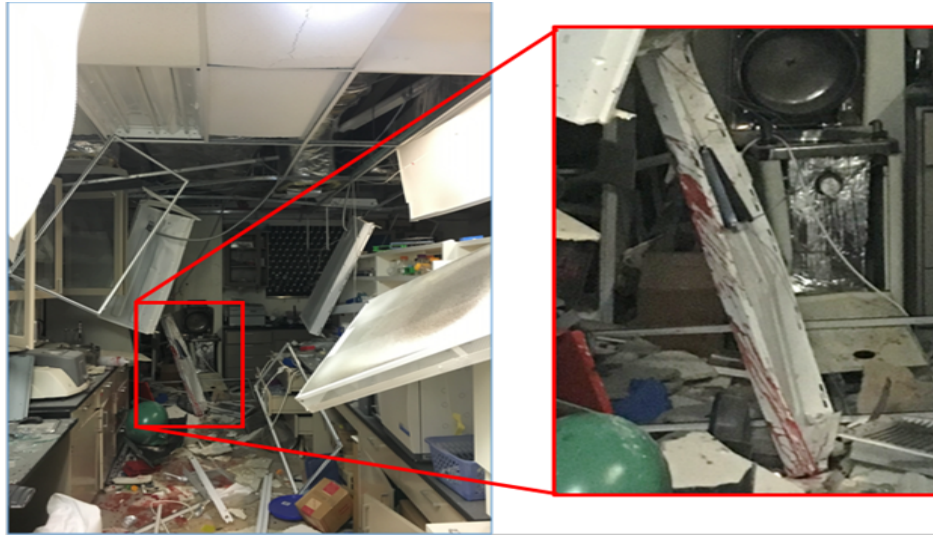
Figures 18 and 19: Photographs taken during HFD⁴⁸ response of the explosion scene with torn down ceiling plates and light fixtures. Both pieces of the tank landed to the left of the Biosafety Cabinet. The autoclave with its lid open is visible in the background. Blood from the injured postdoctoral researcher is visible in various places. The inset shows a ceiling light panel from in front of the biosafety cabinet that was impacted by the ball valve assembly and a remnant of the gas storage tank (green) can be seen in the lower left corner.

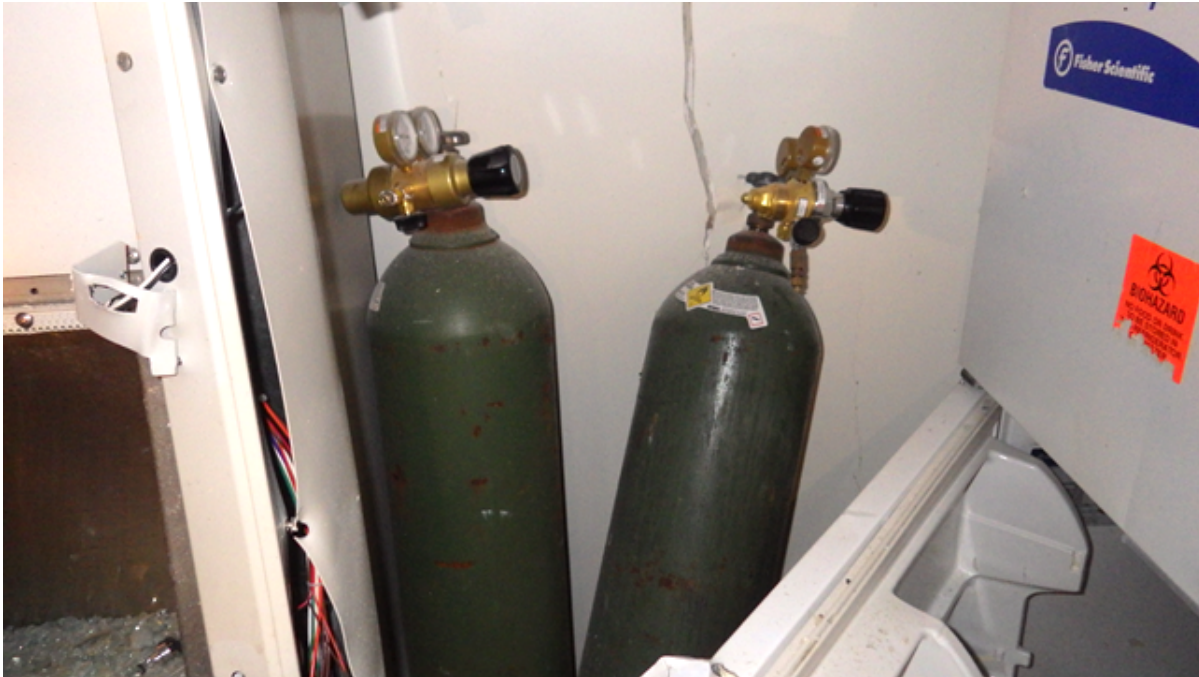
Figure 21: Oxygen cylinders used to fill the gas storage tank (standing upright) and used for the second postdoctoral researcher's ongoing experiment (tilted). The latter oxygen cylinder was open at the time of the explosion.

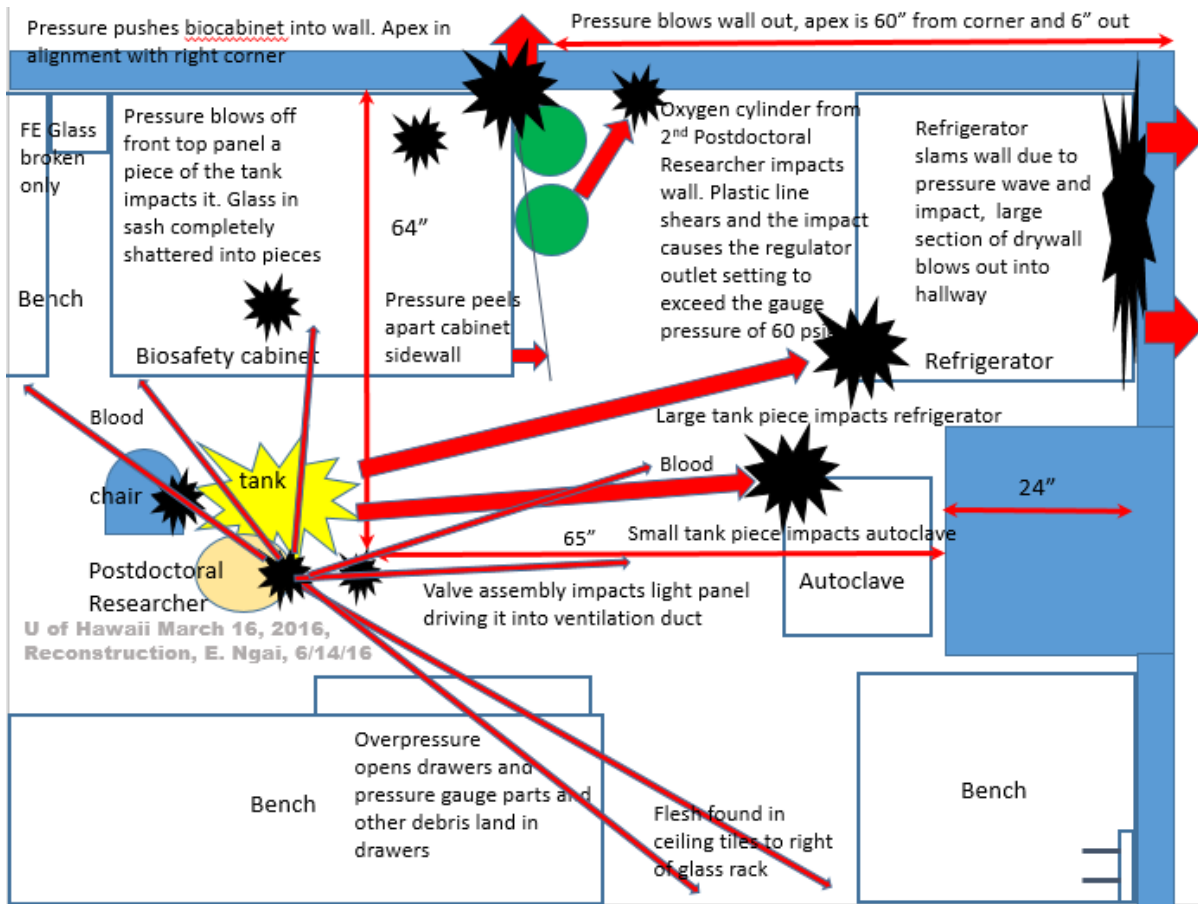
Figure 23: Summary map of the explosions effects.

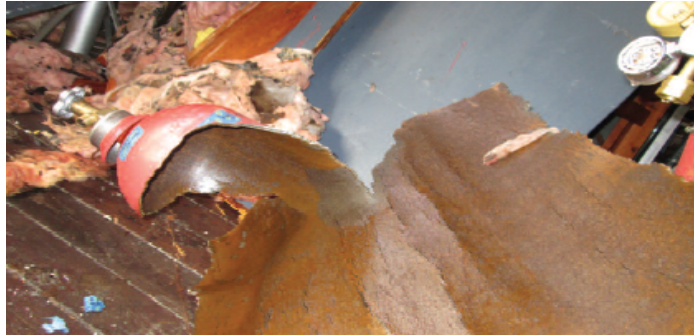
Figure 24: Cylinder embrittlement; note jagged edge and interior surface cracks⁵⁵

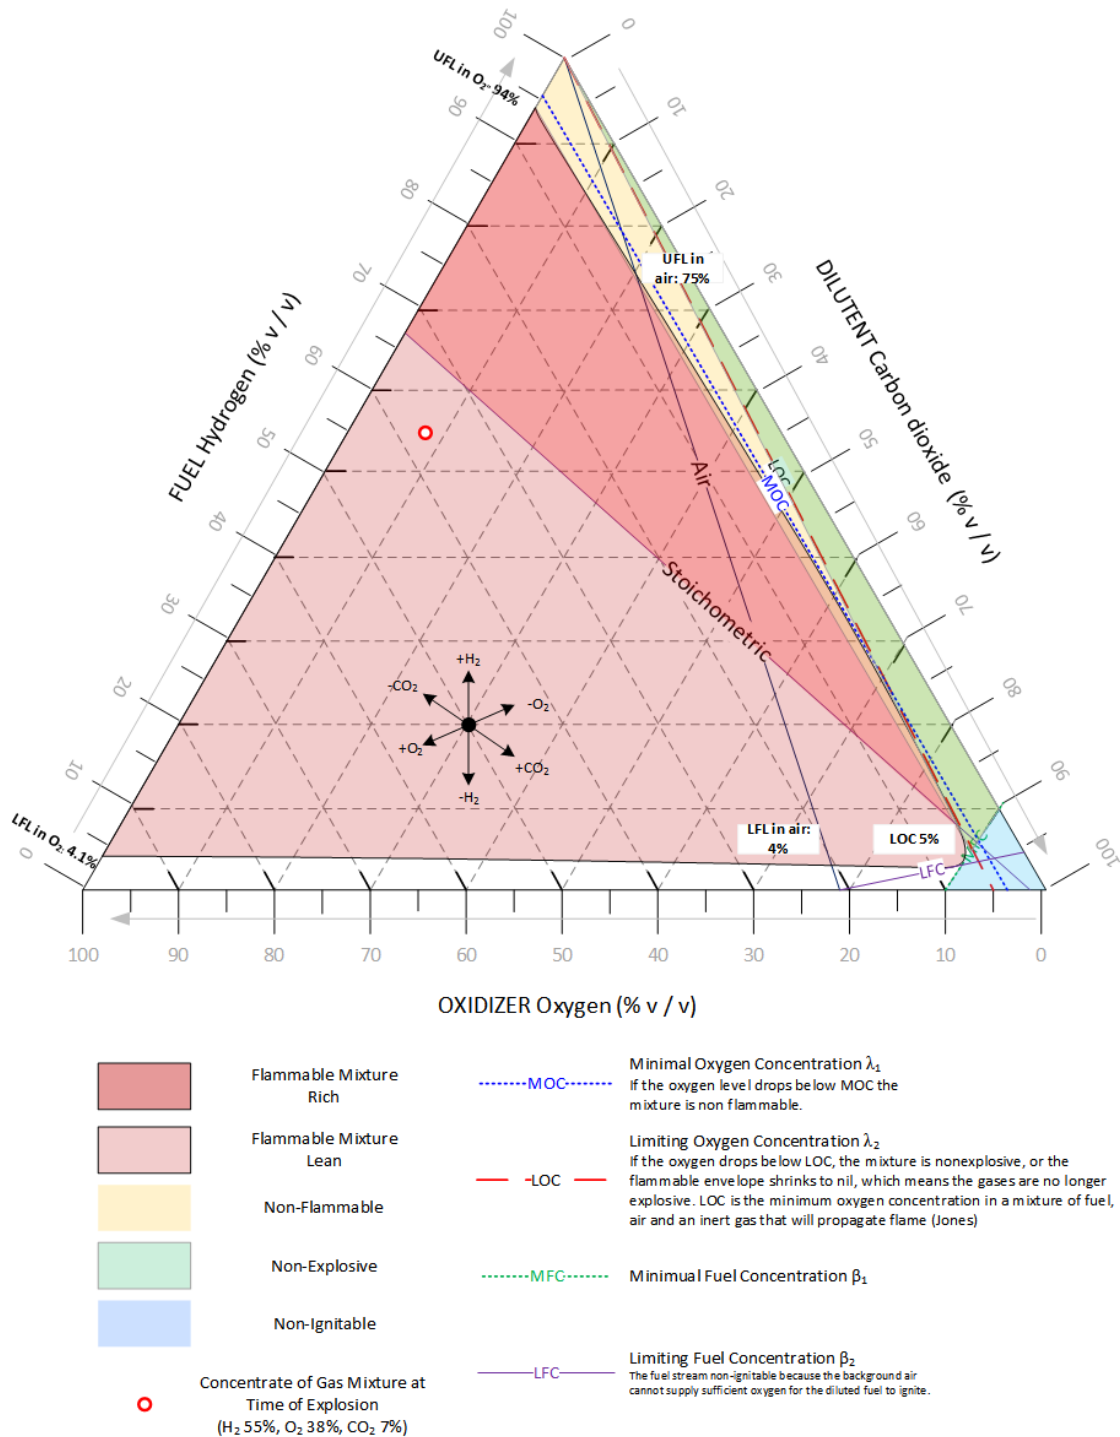
Figure 25: Fire diagram for hydrogen/oxygen gas mixtures. Flammability diagrams show the regimes of flammability in mixtures of a flammable and oxidizer gas diluted with an inert gas such as carbon dioxide that was used in the

experiments in the UH lab⁶⁰. The red circle indicates the gas mixture at the time of the explosion, 55% H₂ : 38% O₂ : 7% CO₂. LFL, Lower Flammability (or explosibility) Limit; UFL, Upper Flammability Limit.

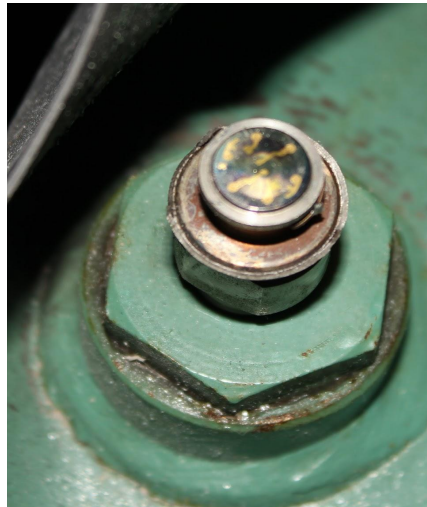
The Ashcroft digital pressure gauge⁶⁹ employs a thin pressure diaphragm made of 17-4 PH stainless steel where strain sensors are attached which are employed to determine the gas pressure (Figure 26). This is the “wetted” material that came into contact with gas mixture inside the tank⁷⁰. Under high temperatures hydrogen can permeate through the steel diaphragm. Testing by WHA International demonstrated that the diaphragm left on the stem from the pressure gauge on the gas tank was gas leak tight under Helium pressure. Similarly, the diaphragm on an identical new Ashcroft pressure gauge was also leak tight. Threading of the pressure gauge stem into the gas tank bushing, and the bushing into the gas tank, were leak tested by the postdoctoral researcher. Therefore leakage of the explosive gas mixture into the body of the pressure gauge where it was ignited by the electrical circuitry did not occur.

Figure 26: Pressure gauge diaphragm still attached to the threaded gauge stem that was still threaded into a bushing on the tank. On the external surface (non-wetted side) of the diaphragm one can see markings where the strain sensors were attached to the diaphragm.

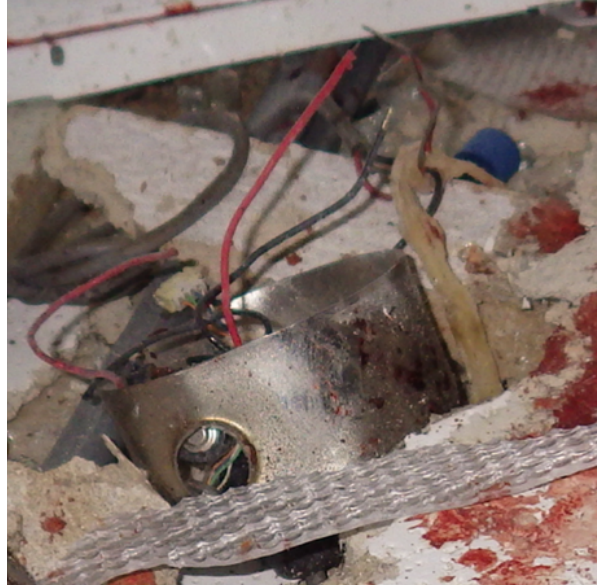
Physical evidence shows that the pressure gauge from the tank came apart in multiple pieces. HFD Fire Investigator stated that when he visually inspected the pressure gauge metal housing that evening and it did not appear to be severely damaged due to physical impact (Figure 27).

Figure 27: Pressure gauge housing as found by HFD

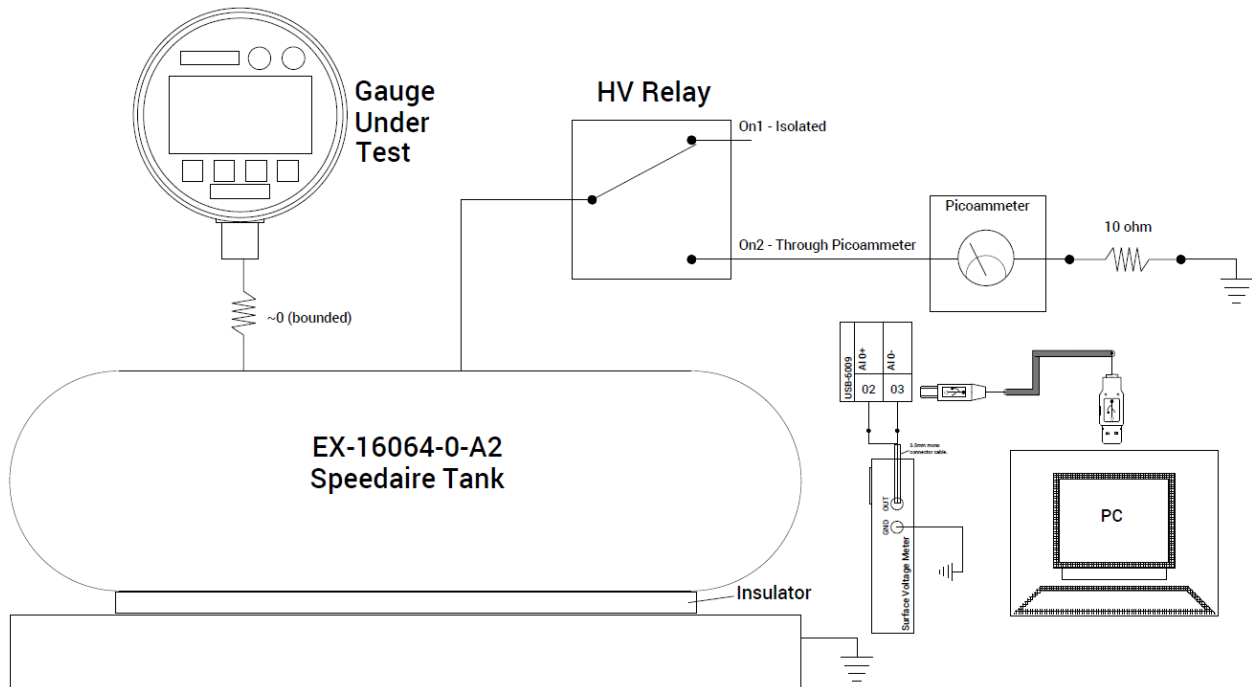
Figure 30: Simplified Surface Voltage and Current-to-Ground Measurement Setup

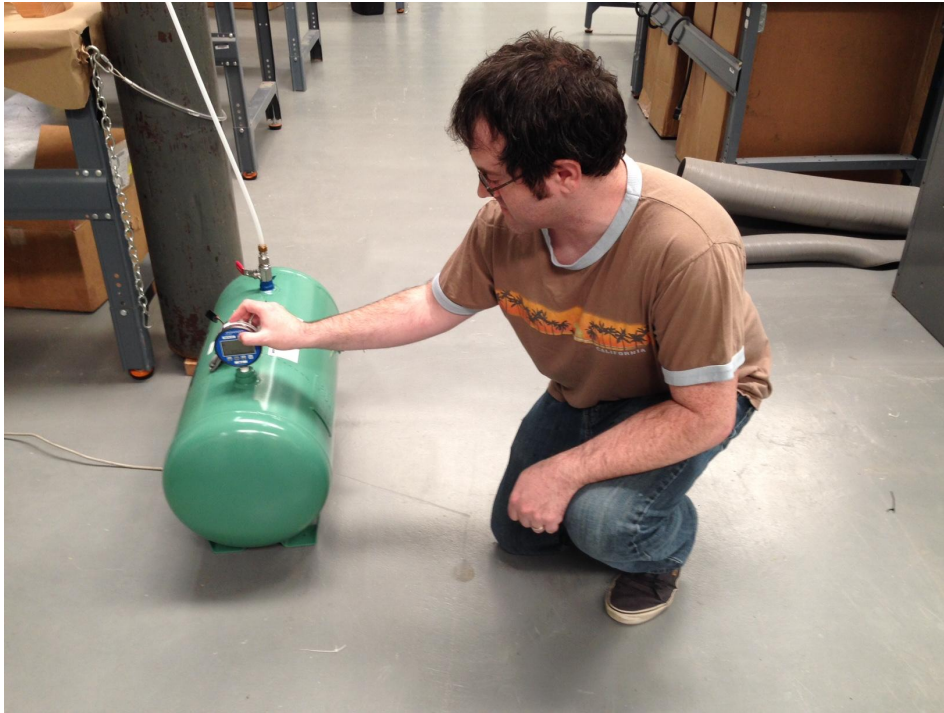
Figure 31: WHA engineer testing static electricity discharge by simultaneously touching the pressure gauge housing and pressing the gauge's On/Off switch

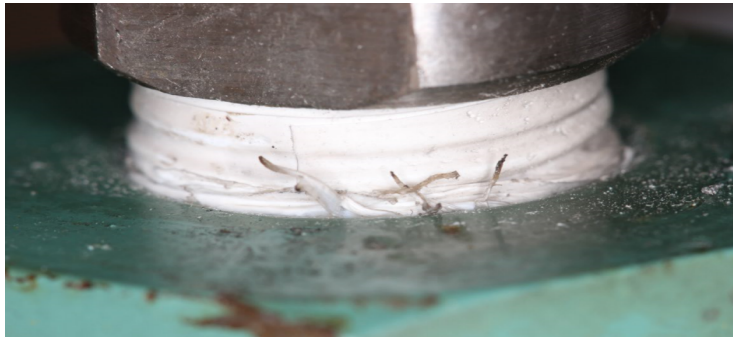
Other interesting findings that could not be pursued included Teflon tape that appeared to be burnt and melted on the gauge sensor stem (Figure 32). There was also pitting observed. Without further examination by destructive and chemical analysis, no further conclusions can be made.

Figure 32: Photo of gauge stem Teflon tape that appears to be charred and melted.

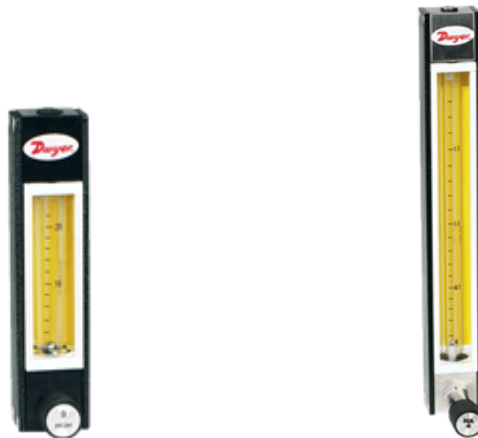
Rotameter operation is based on the variable area principle: fluid flow raises a float in a tapered tube, increasing the area for passage of the fluid. The greater the flow, the higher the float is raised. The height of the float is directly proportional to the flow rate. With liquids, the float is raised by a combination of the buoyancy of the liquid and the velocity head of the fluid. With gases, buoyancy is negligible, and the float responds to the velocity head alone. The float moves up or down in the tube in proportion to the fluid flowrate and the annular area between the float and the tube wall. The float reaches a stable position in the tube when the upward force exerted by the flowing fluid equals the downward gravitational force exerted by the weight of the float. A change in flowrate upsets this balance of forces. The float then moves up or down, changing the annular area until it again reaches a position where the forces are in equilibrium. To satisfy the force equation, the rotameter float assumes a distinct position for every constant flow rate. However, it is important to note that because the float position is gravity dependent, rotameters must be vertically oriented and mounted.

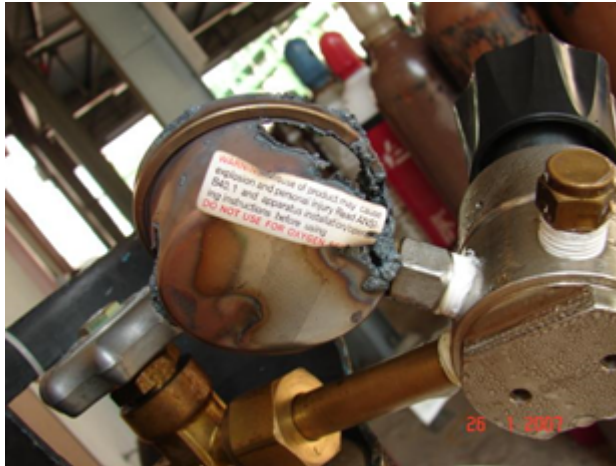
- Accidents have occurred when users needing an oxygen regulator replaced the CGA connection from a regulator used in another service with a CGA 540 connection and attached it to the oxygen cylinder. When the cylinder valve was opened, the adiabatic compression heat reached the autoignition temperature of the contaminant in pure oxygen.

Regulator used for another gas service was adapted for oxygen use and exploded when the cylinder valve was opened.
